**TEST REPORT**

**HOMELAND VINYL PRODUCTS, INC.**

***Gorilla® Column PVC Porch Post System***  
**with PVC Base / Cap Plates, PVC Bushings and**  
**2-3/8 in Diameter and 3-1/2 in Diameter Galvanized Steel Reinforcing Inserts**

**Report No.: E2328.01-119-16**

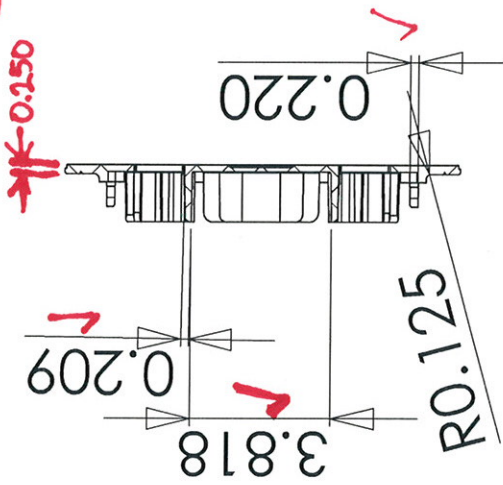
Redesigned

SECTION A-A

| PROPRIETARY AND CONFIDENTIAL | | DO NOT SCALE DRAWING | | PART NUMBER | |
|---|--|---|--|---|--|
| | | Homeland Vinyl Products, Inc.<br>3300 Pinson Valley Pkwy<br>Birmingham, AL 35217<br>phone: 205-854-4330<br>fax: 205-854-3677<br>www.homelandvinyl.com | | <b>Matrix Base</b> | |

*Note: Punching shear testing was conducted on the original post base / cap plate design. The differences between the redesigned base / cap plate and the original were determined to be insignificant and would not affect the punching shear test results. Reference drawings in Appendix A for drawings of both the original and the redesigned base / cap plates.*

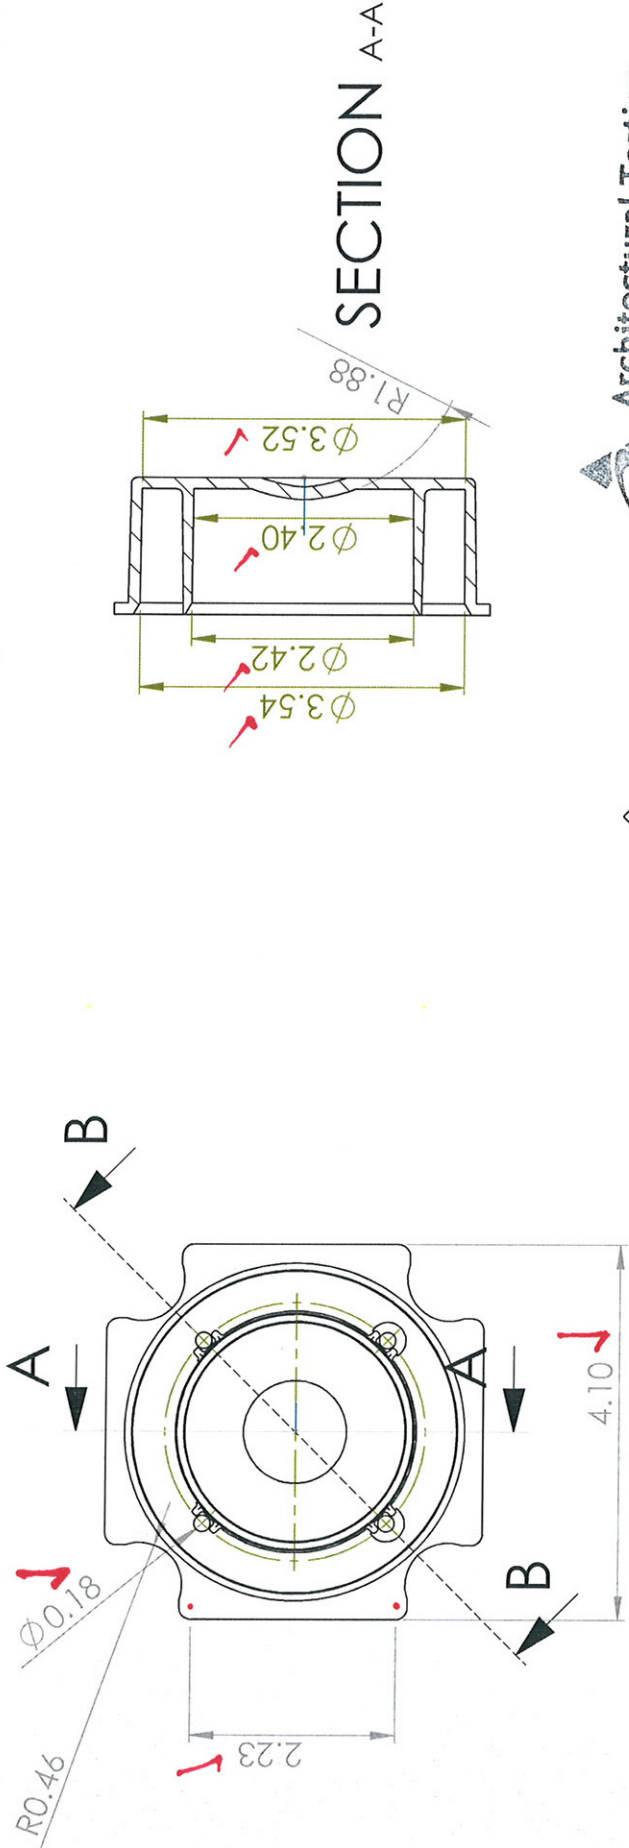
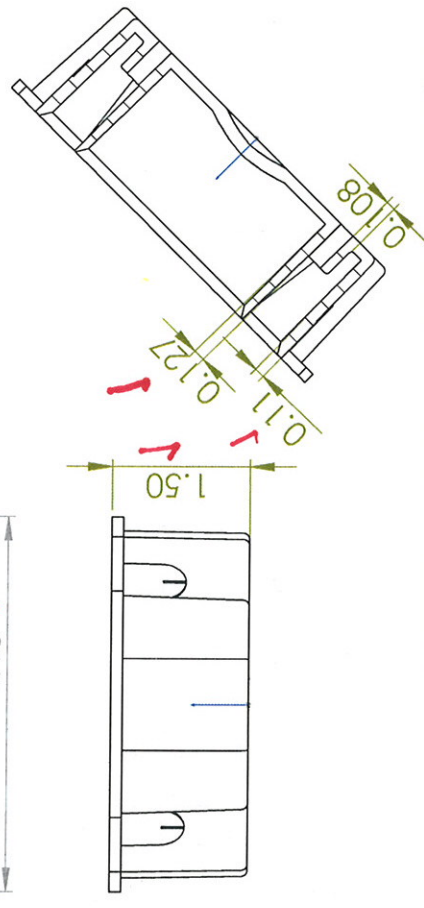
Matrix Bushing

SIZE DWG. NO. **A** Bushing REV

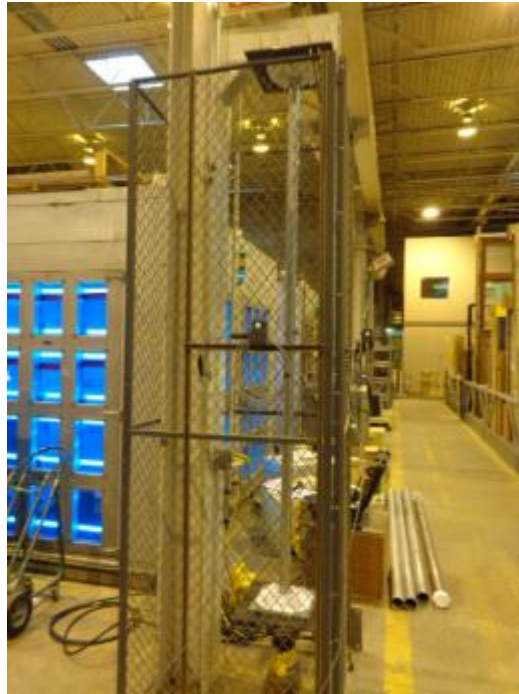
**Photo No. 1**  
**Typical Axial Load Compression Test Setup (108 in length post)**

The test fixture consisted of a flat steel support attached to a rigid steel column at the top. The bottom consisted of a hydraulic jack positioned on a leveling fixture, fitted with a flat steel bearing plate and a 50,000 pound capacity load cell. Test duration, load, and deflection were recorded electronically throughout the test.

The columns were installed into the compression fixture with no physical connections between the column and fixture. The compression fixture was plumbed using a "PLS-5" laser plumbing device, and while applying a minimal preload to hold the test sample in place, the column was leveled with a 78 in level. An electronic linear displacement transducer was positioned at the mid-point of each of two axes on each column to measure lateral displacements about the X- and Y-Axes of the column. Reference photographs in Appendix B for test setups.

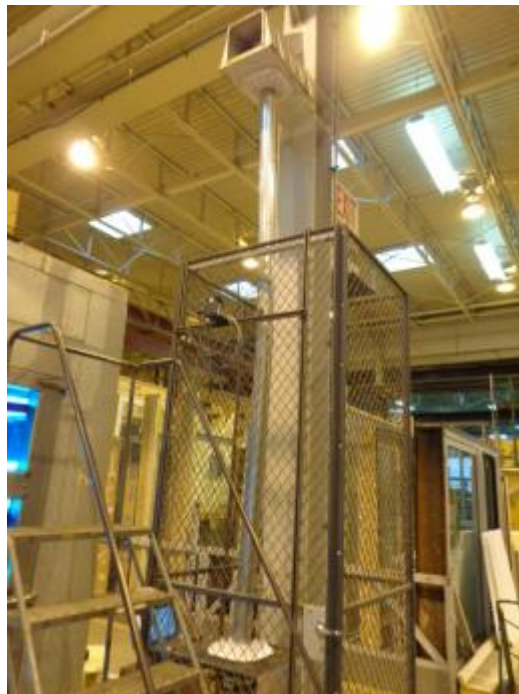
**Photo No. 2**  
**Typical Axial Load Compression Test Setup (120 in length post)**

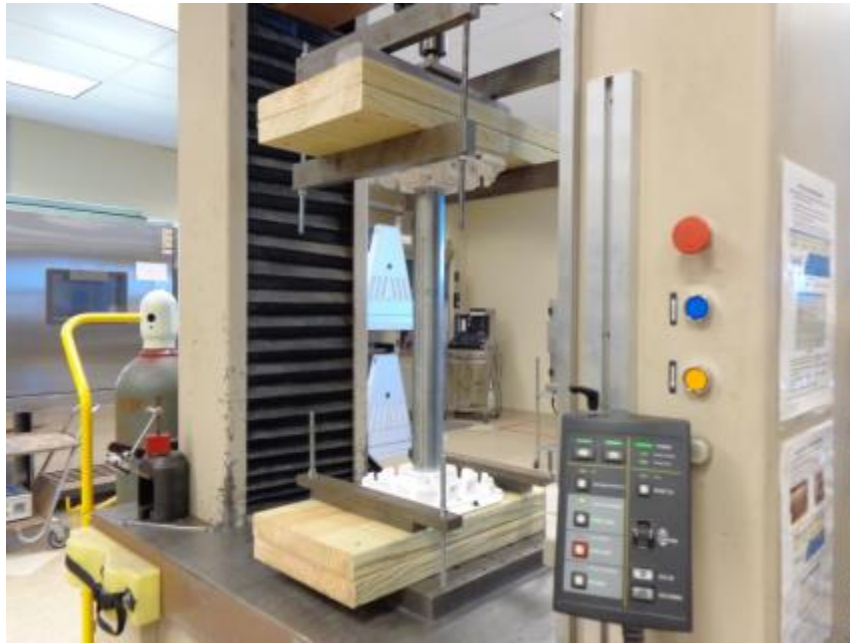
**Photo No. 3**  
**Typical Uplift Load Test Setup**

Short sections of galvanized steel posts were attached at each end to a base / cap plate, bushing and double pressure treated Southern Yellow Pine (SYP) wood boards. The PVC cap / base plates were secured to the wood boards with six 1/4" by 2-1/2" FastenMaster® *TimberLOK*® (0.164 in minor diameter, 0.260 in major diameter, 0.19 in shank diameter, hex washer head) heavy duty wood screws with 3/4 in diameter washers. Tests were conducted at lab ambient temperature (68°F ± 4°F). Reference photographs in Appendix B for test setup.

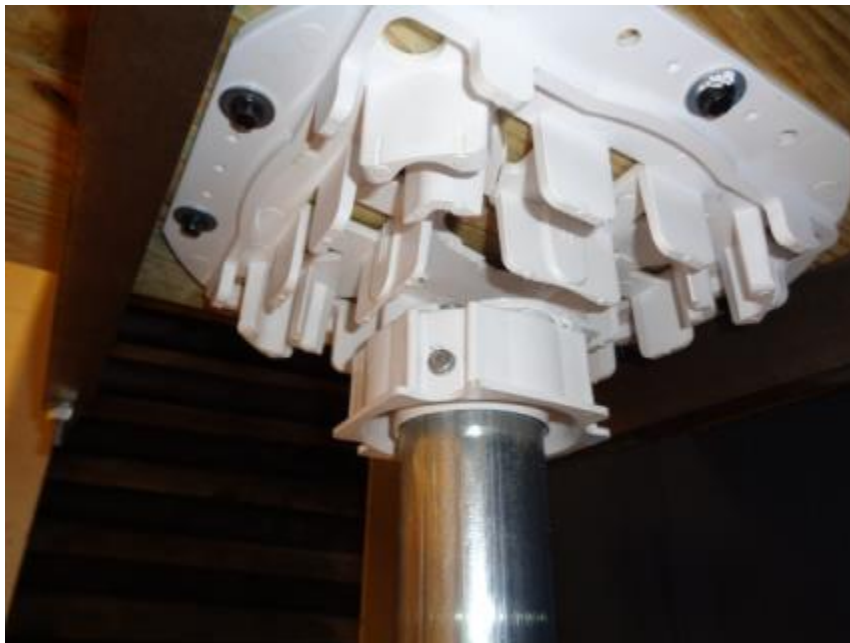
**Photo No. 4**  
**Typical Uplift Load Test Failure - 2-3/8 in Diameter Post**

| Specimen No. | Ultimate Load (lb) | Deviation From Average | Failure Mode |
|---|---|---|--|
| 1 | 1372 | +0.3% | Base / cap plate fractured at the plate to bushing connection screws |

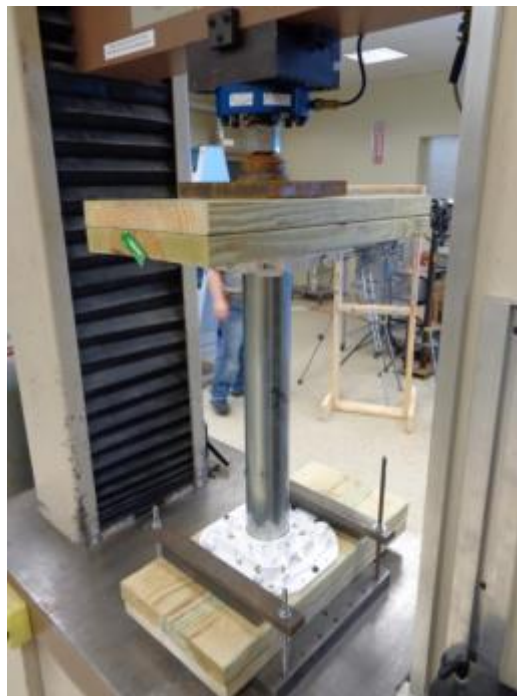
**Photo No. 6**  
**Typical Punching Shear Test Setup**

Short sections of galvanized steel posts were attached at each end to a base / cap plate, bushing and double pressure treated Southern Yellow Pine (SYP) wood boards. The PVC cap / base plates were secured to the wood boards with six 1/4" by 2-1/2" FastenMaster® *TimberLOK*® (0.164 in minor diameter, 0.260 in major diameter, 0.19 in shank diameter, hex washer head) heavy duty wood screws with 3/4 in diameter washers. Tests were conducted at lab ambient temperature (68°F ± 4°F). Reference photographs in Appendix B for test setup.

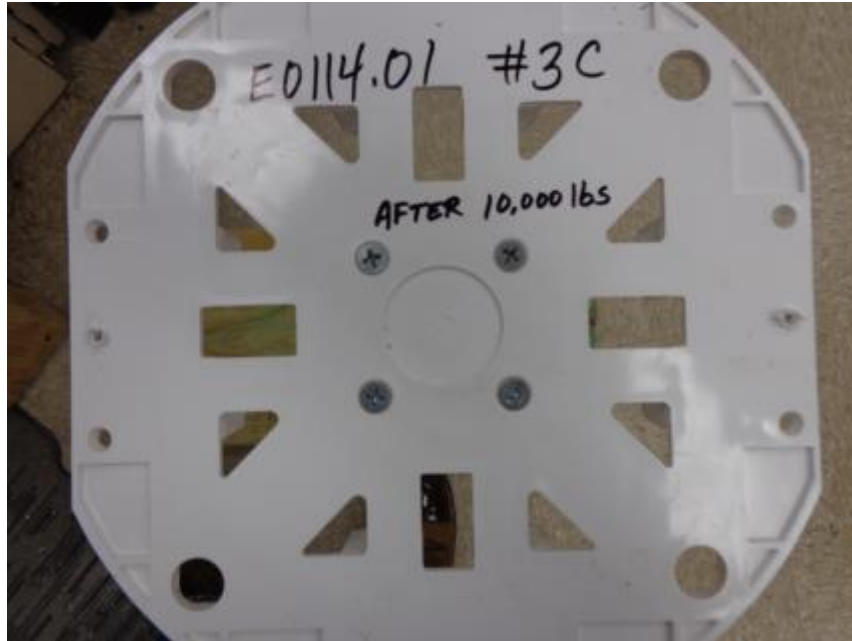
**Photo No. 9**  
**Punching Shear Test Results Following 10000 lbs of Load - 2-3/8 in Diameter Post**  
**(Specimen 3 - Underside)**

| Specimen No. | Ultimate Load (lb) | Deviation From Average | Failure Mode |
|---|---|---|--|
| 3 | 10088 <sup>1</sup> | -30.9% | The only visible damage was the #12 fasteners bent in a down-ward angle. There was no visible deformation of post mount base / cap or bushing. |

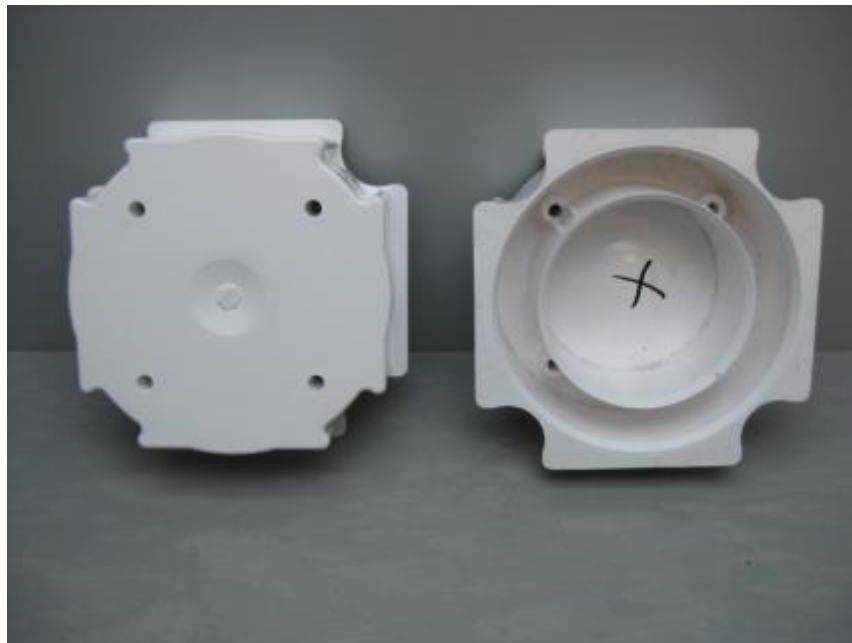
**Photo No. 14**  
**Bushing (Bottom Surface Left; Top Surface Right)**

All test specimens used for testing reported herein were supplied by Homeland Vinyl Products Inc. Each post assembly included a section of galvanized steel post reinforcing, 10-3/4 in by 10-3/4 in by 1-1/2 in (overall thickness) PVC base / cap plate and a 4-1/8 in by 4-1/8 in by 1-1/2 in (overall thickness) PVC bushing. Connection details for each test specimen were as follows:
